ENGINEERING CASE LIBRARY

A HELICOPTER'S LAST HOP

A helicopter was making a turn and slowing to get into position to deposit a load transported at the end of a sling. The helicopter crashed, killing the pilot, and demolishing the helicopter. What happened?

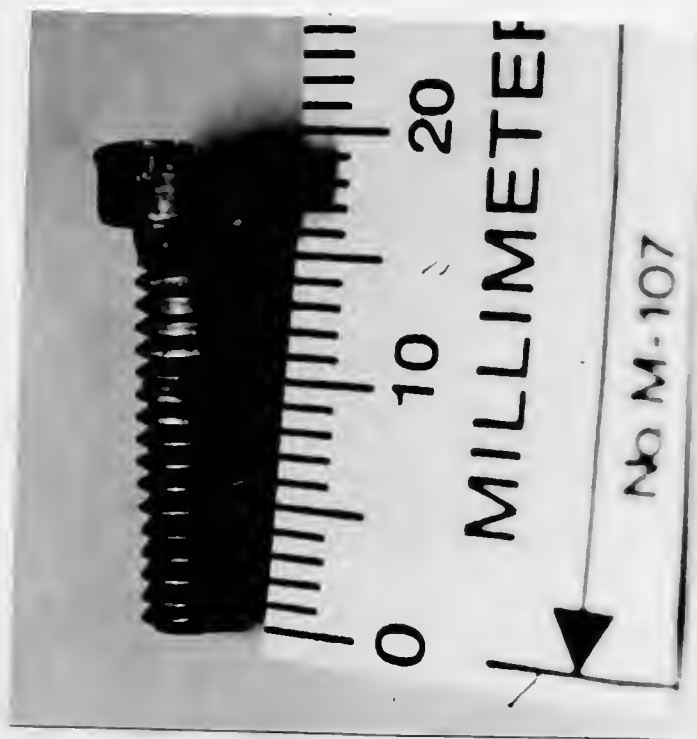
Photographs 3 and 4 show the "bore hole elongation" indicated in the NTSB report. Photographs 1 and 2 show the screw head "filed down" as noted in the NTSB report. The scoring on the titanium impeller

Photo 1. Labyrinth locking screw found loose in failed helicopter engine. Arrow indicates region of deformed threads.

Photographs 1 and 2 show regions on the screw in which the threads are deformed. Photograph 3 shows a region in the aluminum seal plate in which there is deformation, including thread impressions, in the recess for the screw head. Dr. Manhunt's aluminum hardness reading of Rockwell E-53 would indicate a yield strength of about 21 ksi (146 Mpa). Using the measured areas of deformation with this strength, Dr. Faber estimated that the force required to make this deformation was about 900 lb (4000 N). This force is essentially the friction force between the screw head and the impeller face. Knowing the bolt circle diameter, the torque on the impeller from the screw friction was calculated as 228 ft-lb (310 N-m). Using the mass moment of inertia of the engine and the two rotors [0.23 kg-m² (5.5 lb-ft²), found in Spinmaker data during discovery], he calculated the decrease in rotational speed of the engine over 1 second of operation as given in Exhibit 3. Assuming the estimate of deformation force was in error by a factor of 2, that decrease in speed is also shown in Exhibit 3. He believed either loss of speed in that short a time was more than great enough to lead to engine burnout.

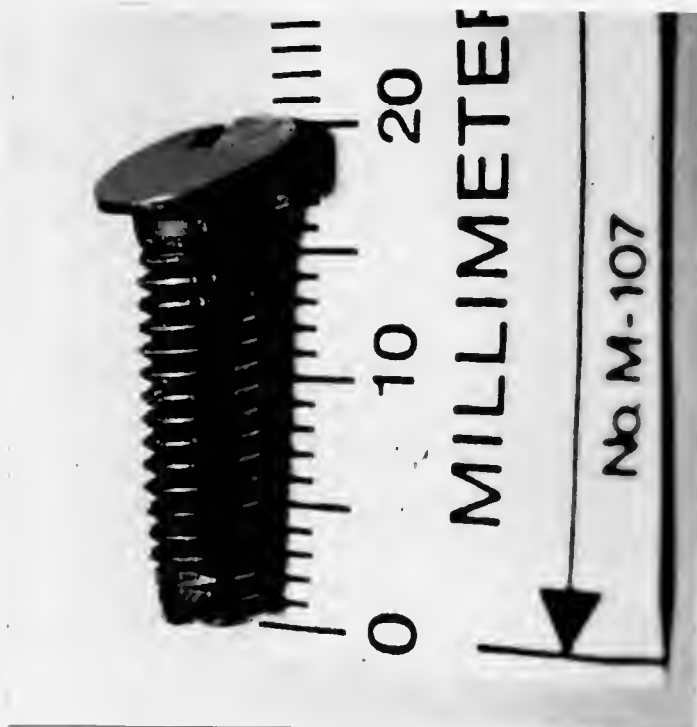
Photo 2. Labyrinth locking screw shown at 180° from its orientation in Photo 1. Arrow indicates region of deformed threads. Note the head has been "ground" to a "wedge" shape.

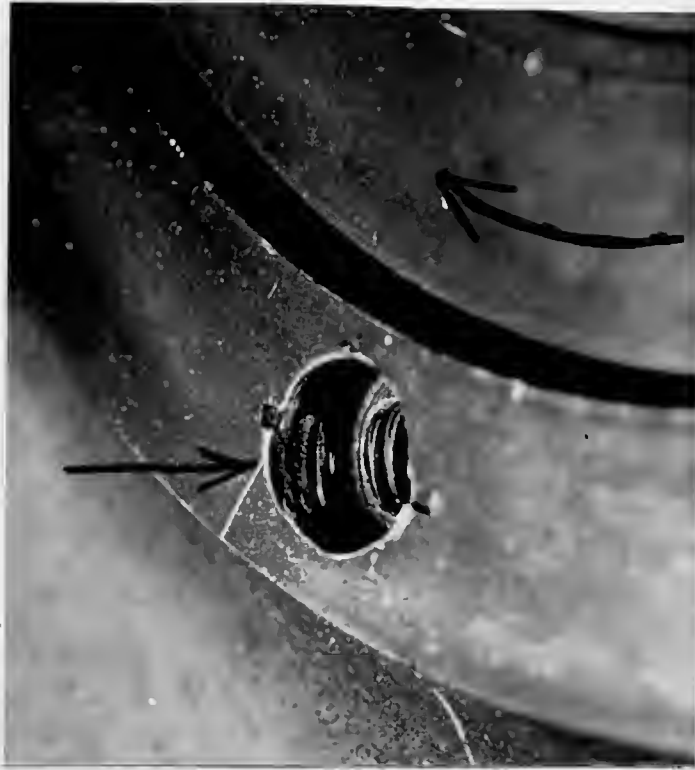
Photo 3. Recessed hole in aluminum labyrinth seal. Straight arrow indicates deformed region in drilled recess and hole. Curved arrow indicates direction of rotation of titanium impeller relative to the aluminum seal. Screw in Photos 1 and 2 came from this hole.

It is noted that both Photographs 3 and 4 show deformation of the aluminum seal plate. The two deformations, however, are approximately diametrically opposite. In Dr. Faber's opinion, the deformation shown in Photograph 3 was caused by wedging of the screw leading to engine failure. The deformation shown in Photograph 4, on the other hand, was caused by the screw being forced "backward" on impact of the helicopter with the ground. This is consistent with the indication in the NTSB report that the "screw stem was opposite to the compressor's direction of rotation."

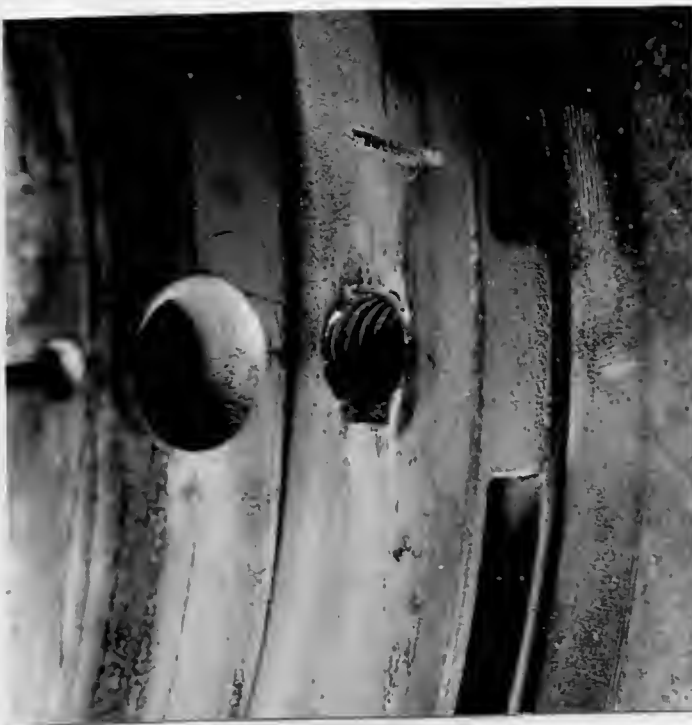
Photo 5. Bottom of hole in steel diffuser cover. Screw in Photos 1 and 2 came from this hole.

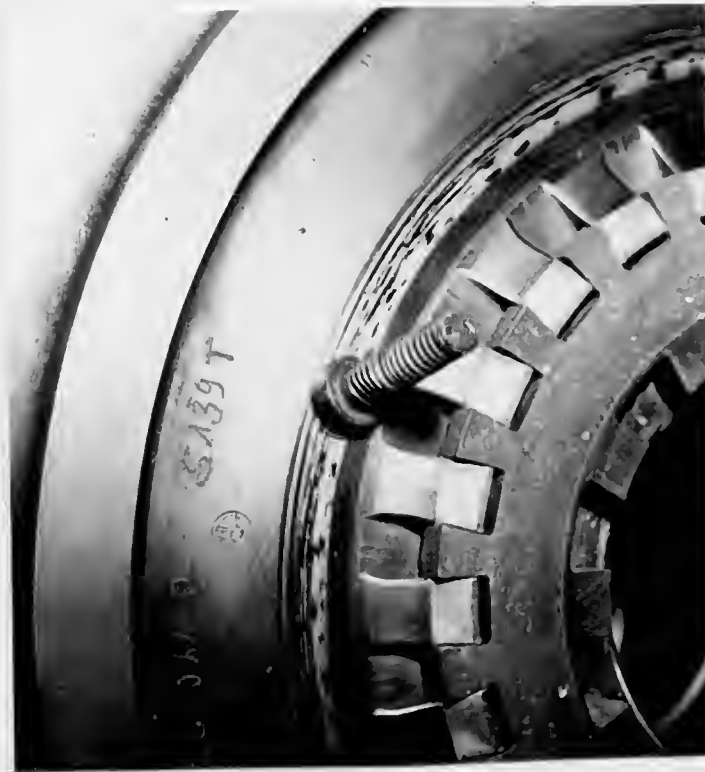
(alloy unknown) noted in the NTSB report is shown in Photographs 6 and 7. The scoring is sufficiently pronounced that some small scratch lines are visible to the unaided eye.

Photo 6. View of face of titanium impeller showing "rubbed" or "abraded" area with screw from Photos 1 and 2. The width of the abraded band is approximately the same as the diameter of the screw head.

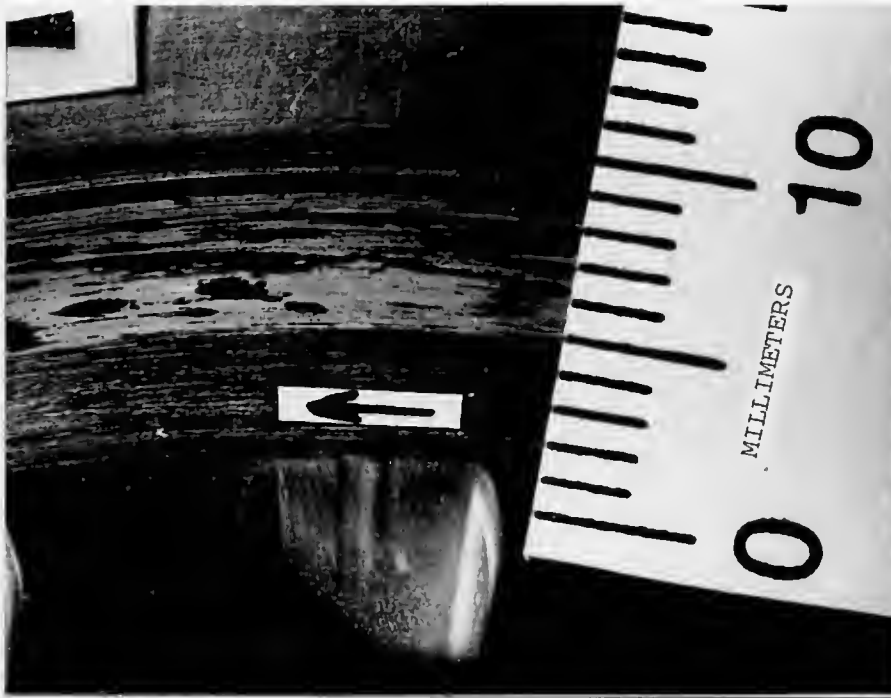
Photo 7. Closer view (than in Photo 6) of a portion of the abraded area on the face of the titanium impeller. Arrow indicates direction of rotation.

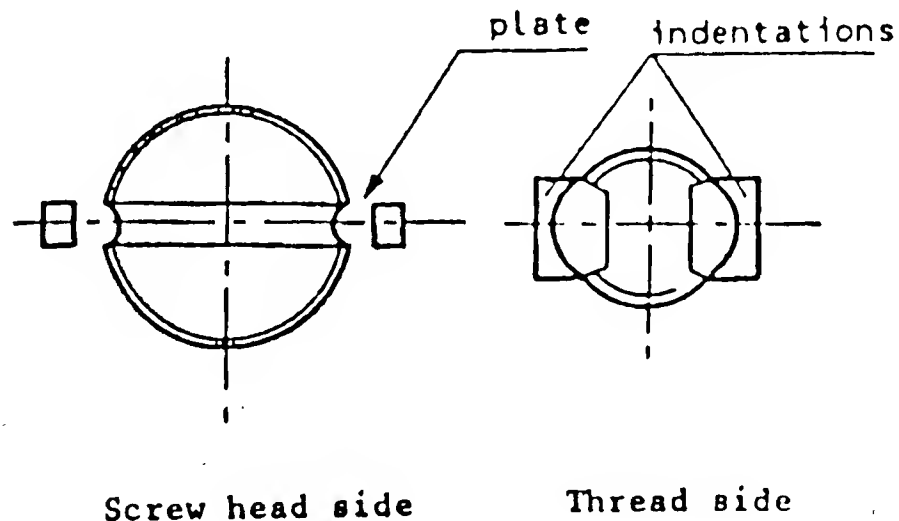
EXHIBIT 2

To improve locking of screws securing front labyrinth to diffuser cover.

Locking of the six screws attaching labyrinth to cover was achieved by punching. This is improved by additional locking on both sides:

- a - Head side: Metal from surrounding surface of plate is forced into both ends of the screw slots.
- b - Thread side: Metal of the screws is forced into two milled indentations on either side of the six drilling of the labyrinth.

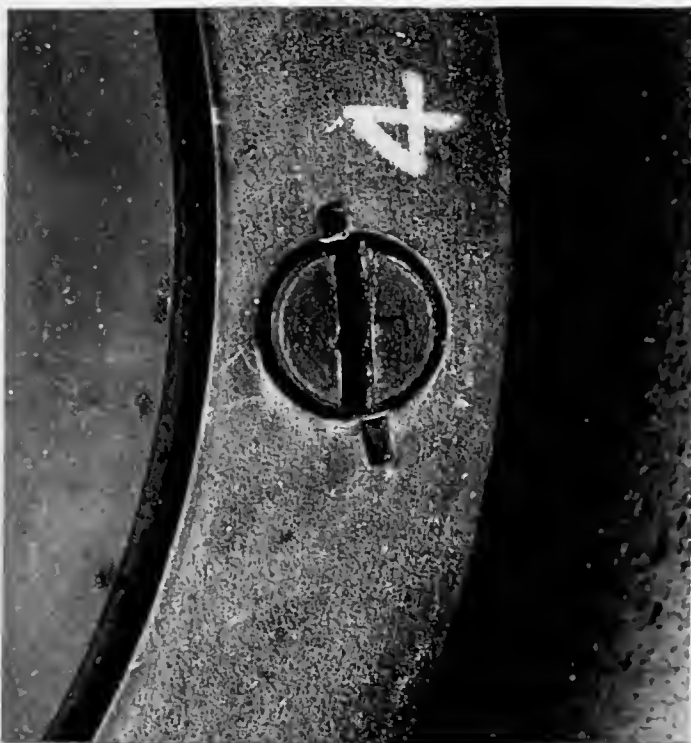
[The engine in this helicopter (Engine No. 1099) had been modified in accordance with this service bulletin. Photograph 8 shows the head of one screw in Engine No. 1099 after the crash. Photograph 9 shows the thread end of another screw in the same engine.]

Photo 8. View of head of one of the labyrinth locking screws in the failed engine. The slot in the head does not line up in the manner indicated in Exhibit 2.

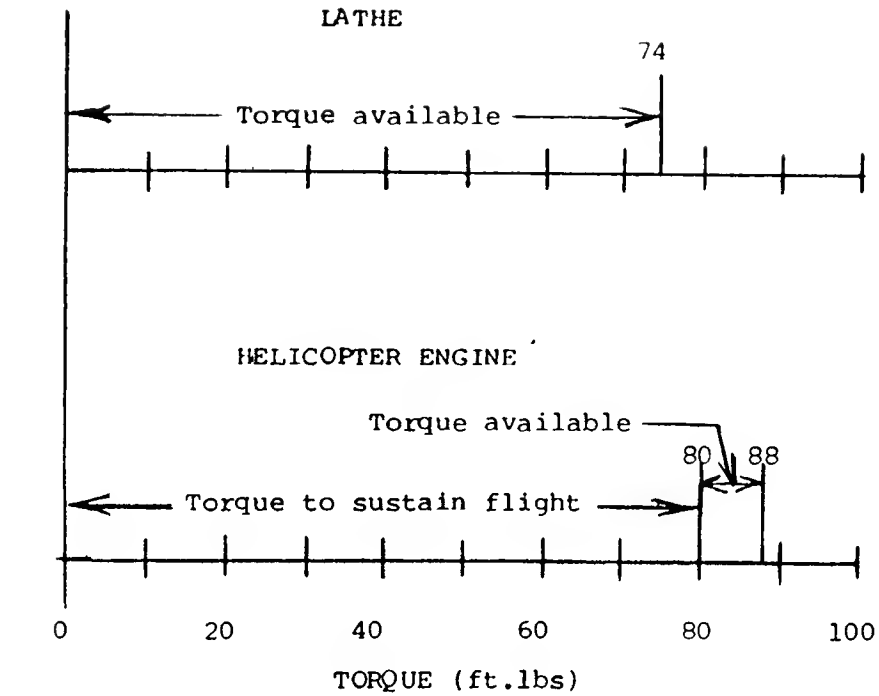
Mr. Piston also considered the tests that Dr. Manhunt performed on the lathe. The rating of Dr. Manhunt's lathe was unknown. Assuming a 14 HP (10.5 N-m) lathe, Mr. Piston made calculations as shown in Photograph 10. In Dr. Manhunt's test, all of the torque [74 ft-lb (100 N-m)] (at 1000 rpm) was available to resist the effect of the screw. In the engine running under load, only 8 ft-lb (10.8 N-m) was available to resist the effect of the screw.

Photo 10. Comparison of torque available for interaction between a labyrinth screw and a rotating titanium plate or impeller in the case of a 10.5 kW (14 HP) lathe and the failed helicopter engine.
